N-Pumps solve clogging problems at Vancouver Island's Victoria Hospital and improve health & safety conditions for the maintenance employees.

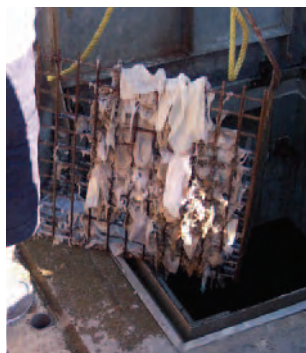
One of the screens collecting solid materials from getting into the wet well.

Another solution that was put in place was to build a couple of screens that were installed before the inlet of the station. The screen collects and prevents the solid materials from getting into the wet well thereby preventing the pumps from clogging. With the screen in place, the hospital's maintenance crew is tasked with the job of cleaning the screen twice a day, once

in the morning and once in the late afternoon. The materials normally removed by the baskets as experienced by the maintenance crew are:

- Face Cloths: 6-8 per day, could be as high as 12;
- Small Towels: 2 or 3 per week;
- Rubber Gloves: 15-30 per day (visual estimate; not counted individually);
- Paper Towels: 50-75 per day (so many, hard to count).
